# **REPORT OF MARINE SURVEY**

**Pre-purchase condition & value.  
of the vessel**

**1998 Somerset 18 X 97 Houseboat**

**Gary Swearengin AMS ® 761 S.A.M.S  
on  
2/8/2018**

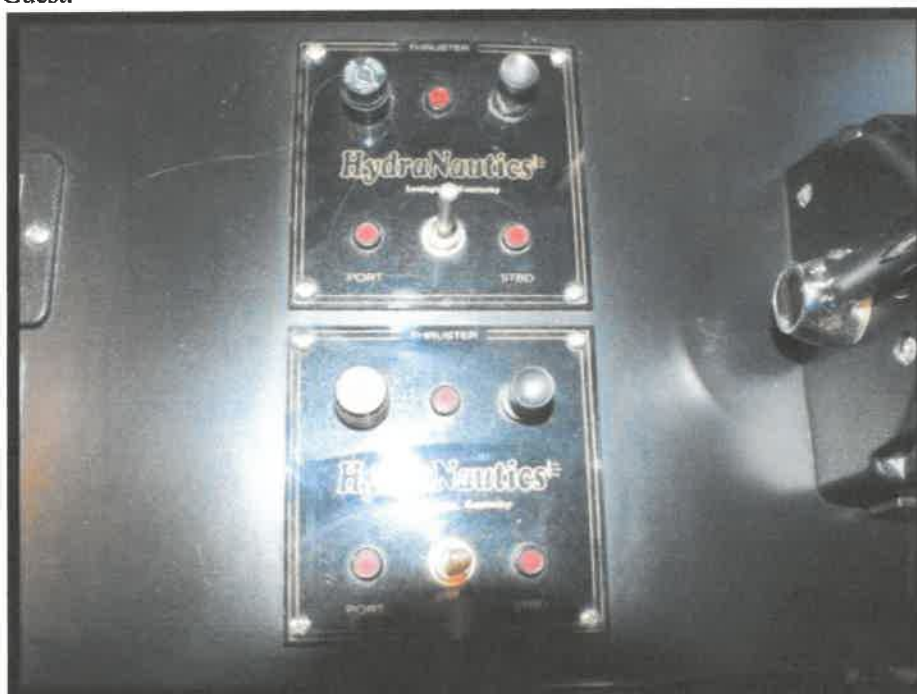
<b>12 volt outlet:</b>	Yes-Not tested.
<b>Antenna(s):</b>	VHF. securely mounted on radar arch.
<b>Courtesy lights:</b>	Functional.
<b>Spotlight controls:</b>	Guest.
<b>Thrusters:</b>

HydraNautics both bow and stern-Not connected at time of survey.

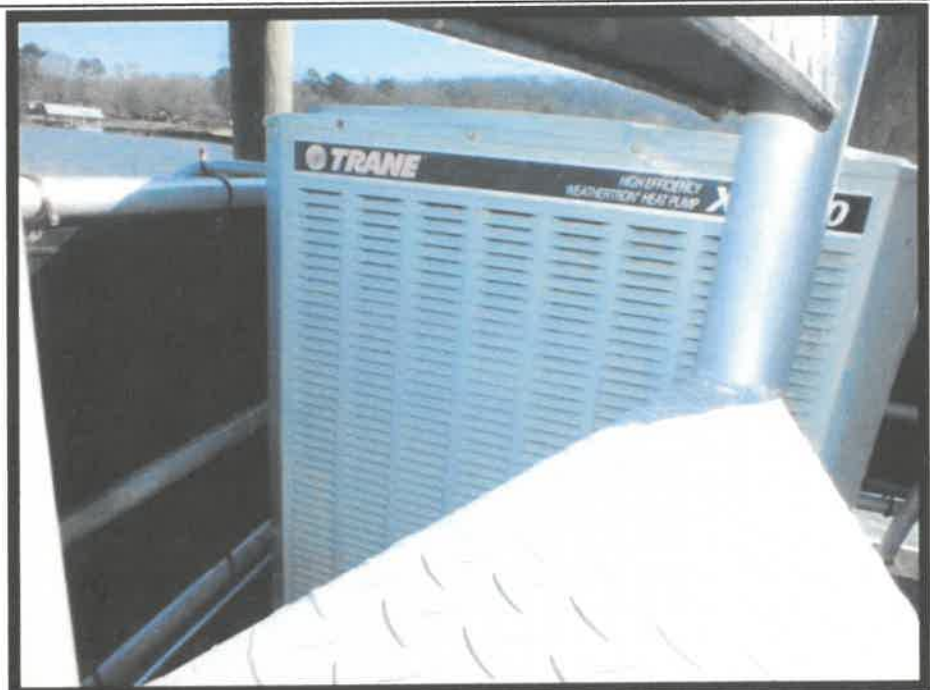
**Manufacturer & Type:**

Trane household type estimated to be 4 ton unit.

Filters appeared clean. Surveyor recommends that A/C filter(s) be checked and cleaned frequently to allow the A/C unit to operate at maximum efficiency.

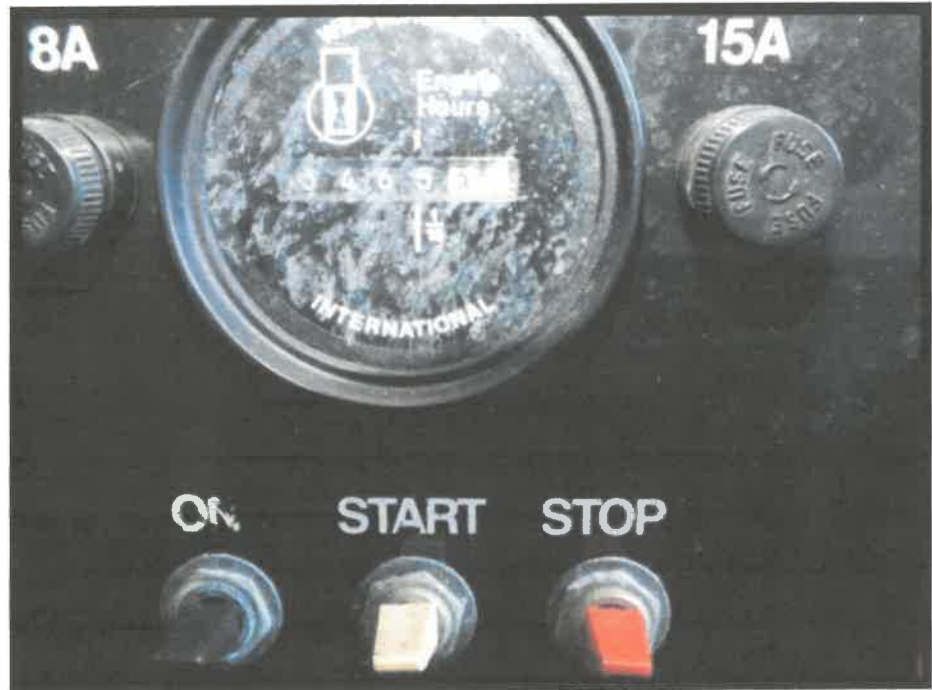
**Hour meter:**

3465.3.  
Could not start generator as the stern thruster has been removed for maintenance and battery is disconnected by maintenance personnel.

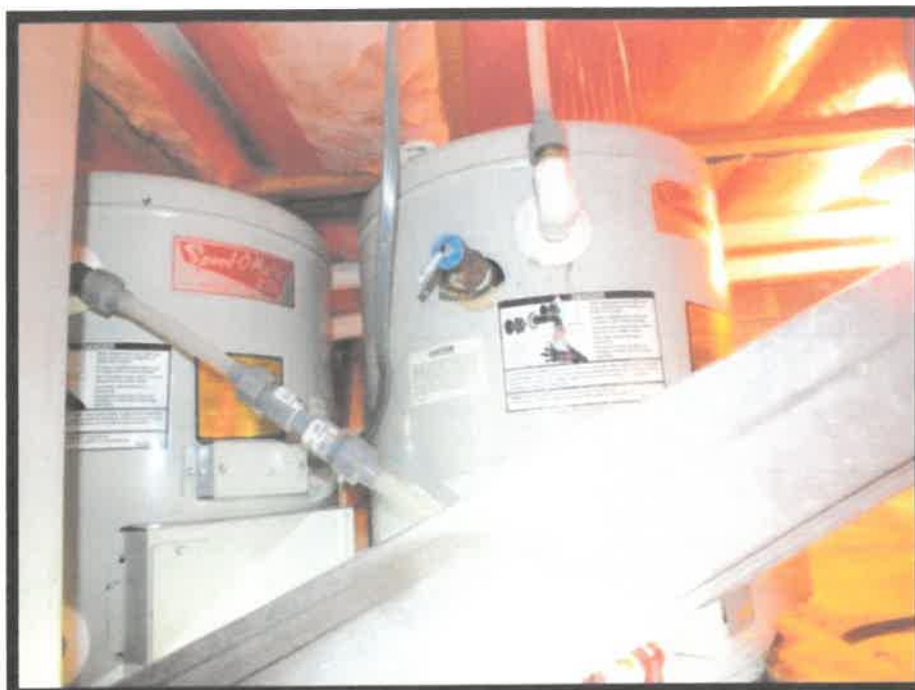
**Manufacturer/capacity:**

Tank was built by: Speed-O-Matic, The capacity is 17 gallons each.  
110V no heat exchanger installed.  
Did not observe label on water heater as being ignition protected. The water heater is not in a gasoline powered engine space but in a separate sealed compartment.  
Water heater tested using 110V system and found fully functional.  
Yes- Drains into bilge area.  
Yes- Appears functional.  
No leaks sighted.  
Galvanized.  
Yes, Tank is well secured to base.  
Good.  
*NOTE: Do not leave hot water heater AC switch on unless water is in the hot water tank or the heating element will burn out. Turn water heater off whenever leaving the vessel.*
